# ***NANO SCRATCH & MAR TESTING***

## ***OF PAINT ON METAL SUBSTRATE***

*We must simulate the process of scratching in a controlled and monitored manner to observe sample behavior effects. In this application, the **NANOVEA** PB1000 Mechanical Tester in Nano Scratch Testing mode is used to measure the load required to cause failure to an approximately 7 year old 30-50  $\mu\text{m}$  thick paint sample on a metal substrate.*

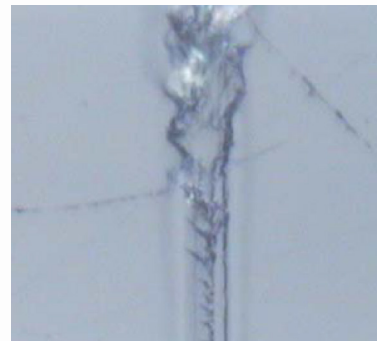
### **CRITICAL FAILURE:**

#### **COMPLETE DAMAGE**

At this point, the damage is more significant where the paint is chipping and cracking along the scratch track.
