PISTON WEAR TESTING

USING A TRIBOMETER

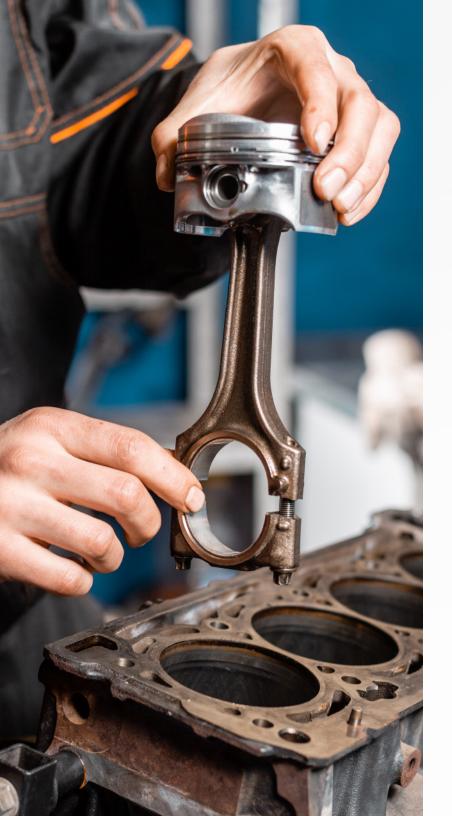
Schematic of power cylinders system and piston skirt-lubricant-cylinder liner interfaces.

A significant portion of the friction loss in the power cylinder system stems from the contact between the piston skirt and the cylinder liner. The interaction between the piston skirt, lubricant, and cylinder interfaces is quite complex due to the constant changes in force, temperature, and speed in a real life engine. Optimizing each factor is key to obtaining optimal engine performance. This study will focus on replicating the mechanisms causing friction forces and wear at the piston skirt-lubricant-cylinder liner (P-L-C) interfaces.

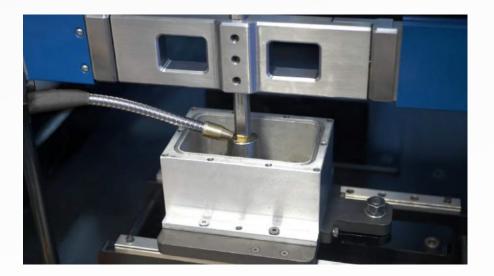
Liquid Module on the NANOVEA T2000 Tribometer.

The drop-by-drop module is crucial for this study. Since pistons can move at a very fast rate (above 3000 rpm), it is difficult to create a thin film of lubricant by submerging the sample. To remedy this issue, the drop-by-drop module is able to consistently apply a constant amount of lubricant onto the piston skirt surface. Application of fresh lubricant also removes concern of dislodged wear contaminants influencing the lubricant's properties.

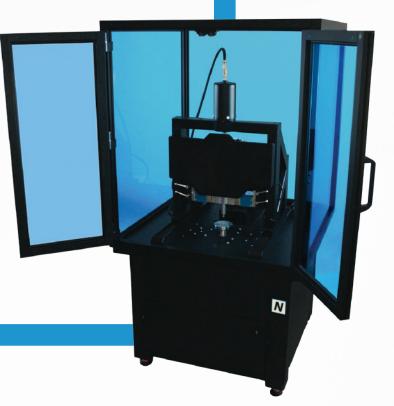
NANOVEA **T2000**

With its wide range of loading (up to 2000 N) and speed (up to 15000 rpm), the **NANOVEA** T2000 tribometer is able to simulate different conditions possible in an engine. Possible future studies on this topic include how the P-L-C interfaces will behave under different constant load, oscillated load, lubricant temperature, speed, and lubricant application method. These parameters can be easily adjusted with the **NANOVEA** T2000 tribometer to give a complete understanding on the mechanisms of the piston skirt-lubricant-cylinder liner interfaces.

It is difficult to understand the P-L-C interfaces without isolating the area from external variables. It is more practical to simulate the event with conditions that are representative of its real-life application. The **NANOVEA** Tribometer is ideal for this. Equipped with multiple force sensors, depth sensor, a drop-by-drop lubricant module, and linear reciprocating stage, the **NANOVEA** T2000 is able to closely mimic events occurring within an engine block and obtain valuable data to better understand the P-L-C interfaces.

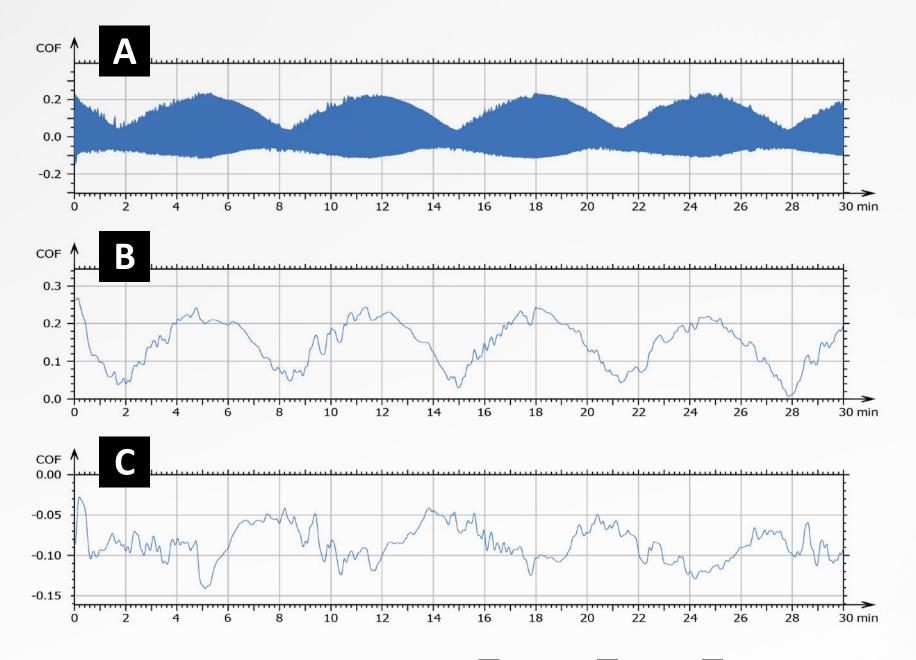
FIGURE 2: COF graphs for 90°C wear oil test A raw profile B high pass C low pass.

[2] "5052 Aluminum vs 356.0 Aluminum." MakeltFrom.com, makeitfrom.com/compare/5052-0-Aluminum/A356.0-SG70B-A13560-Cast-Aluminum The COF of linear reciprocating tribology tests can be split into a high and low pass. High pass refers to the sample moving in the forward, or positive, direction and low pass refers to the sample moving in the reverse, or negative, direction. The average COF for the RT oil was observed to be under 0.1 for both directions. The average COF between passes were 0.072 and 0.080. The average COF of the 90°C oil was found to be different between passes. Average COF values of 0.167 and 0.09 were observed. The difference in COF gives additional proof that the oil was only able to properly wet one side of the pin. High COF was obtained when a thick film was formed between the pin and the piston skirt due to hydrodynamic lubrication occurring. Lower COF is observed in the other direction when mixed lubrication is occurring. For more information on hydrodynamic lubrication and mixed lubrication, please visit our application note on *Stribeck Curves*.

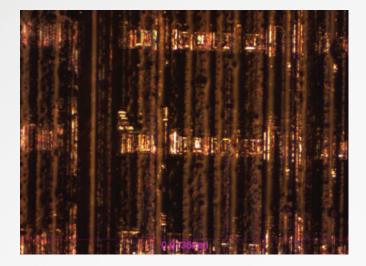
Volume of a hole analysis of wear scar from RT motor oil wear test.

Under the testing conditions, significant wear was observed on the piston skirt at room temperature compared to at 90°C. The deep scratches seen on the samples suggest that contact between the static material and the piston skirt occurs frequently throughout the test. The high viscosity at room temperature may be restricting the oil from completely filling gaps at the interfaces and creating metal-metal contact. At higher temperature, the oil thins and is able to flow between the pin and the piston. As a result, significantly less wear is observed at higher temperature. **FIGURE 5** shows one side of the wear scar wore significantly less than the other side. This is most likely due to the location of the oil output. The lubricant film thickness was thicker on one side than the other, causing uneven wearing.

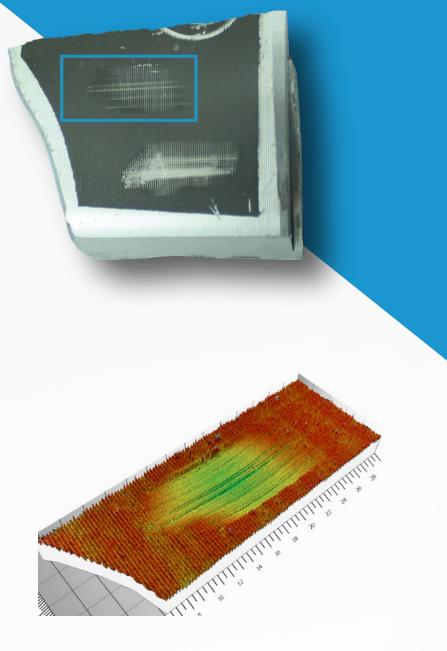
FIGURE 5:

Profilometry scan of wear scar from RT motor oil wear test.

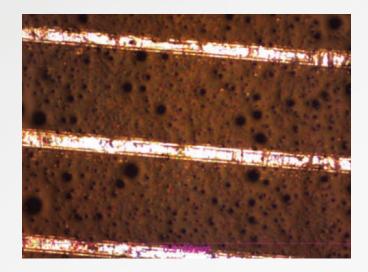
SURFACE	37.69 mm²
<i>VOLUME</i>	129299822 μm³
MAX DEPTH/HEIGHT	10.92 µm
MEAN DEPTH/HEIGHT	3.431 µm

Volume of a hole analysis of wear scar from 90°C motor oil wear test. 111 26.2
